Investigation Report - Japanese and English Version (Summary)

PE02-039

T100 clutch pedal part dash panel cracking failure

1. Problem: Cracking of clutch-pedal bracket attachment dash panel, causing the bracket to move, so that the start switch does not come on, and the engine cannot be started

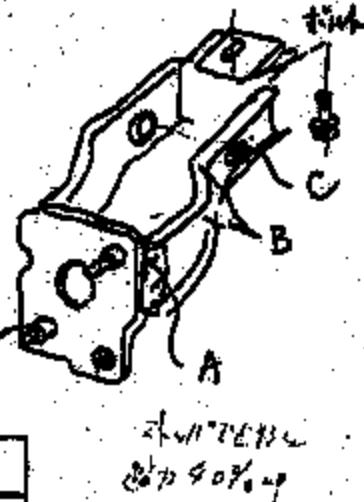
T 100 ペダルプラケット対策

正規 (T=185kgf·cm)			弛み
	15kgf	25kgf	15kgf
A	○	✗ (32万回)	✗ (30万回)
B	○	○	○
C	○	○	○
D	✗ (200万回)	✗ (32万回)	✗ (30万回)

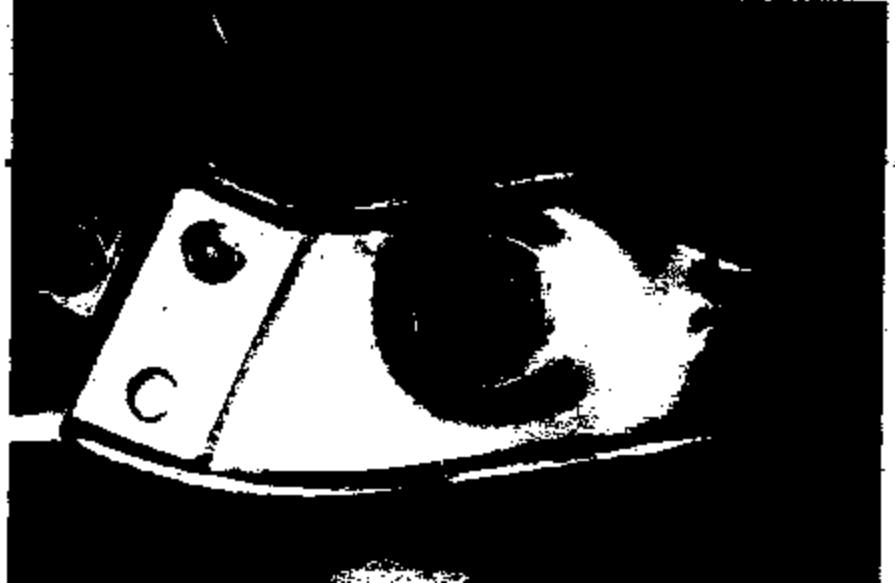
T100.7スチペタル 摘品-1

<1> Damaged T100 clutch pedal - 1

<>> Cracking

<>> Damaged part 2 shows cracking in this area, but this part has no cracking

<>> Cracking on damaged part 2

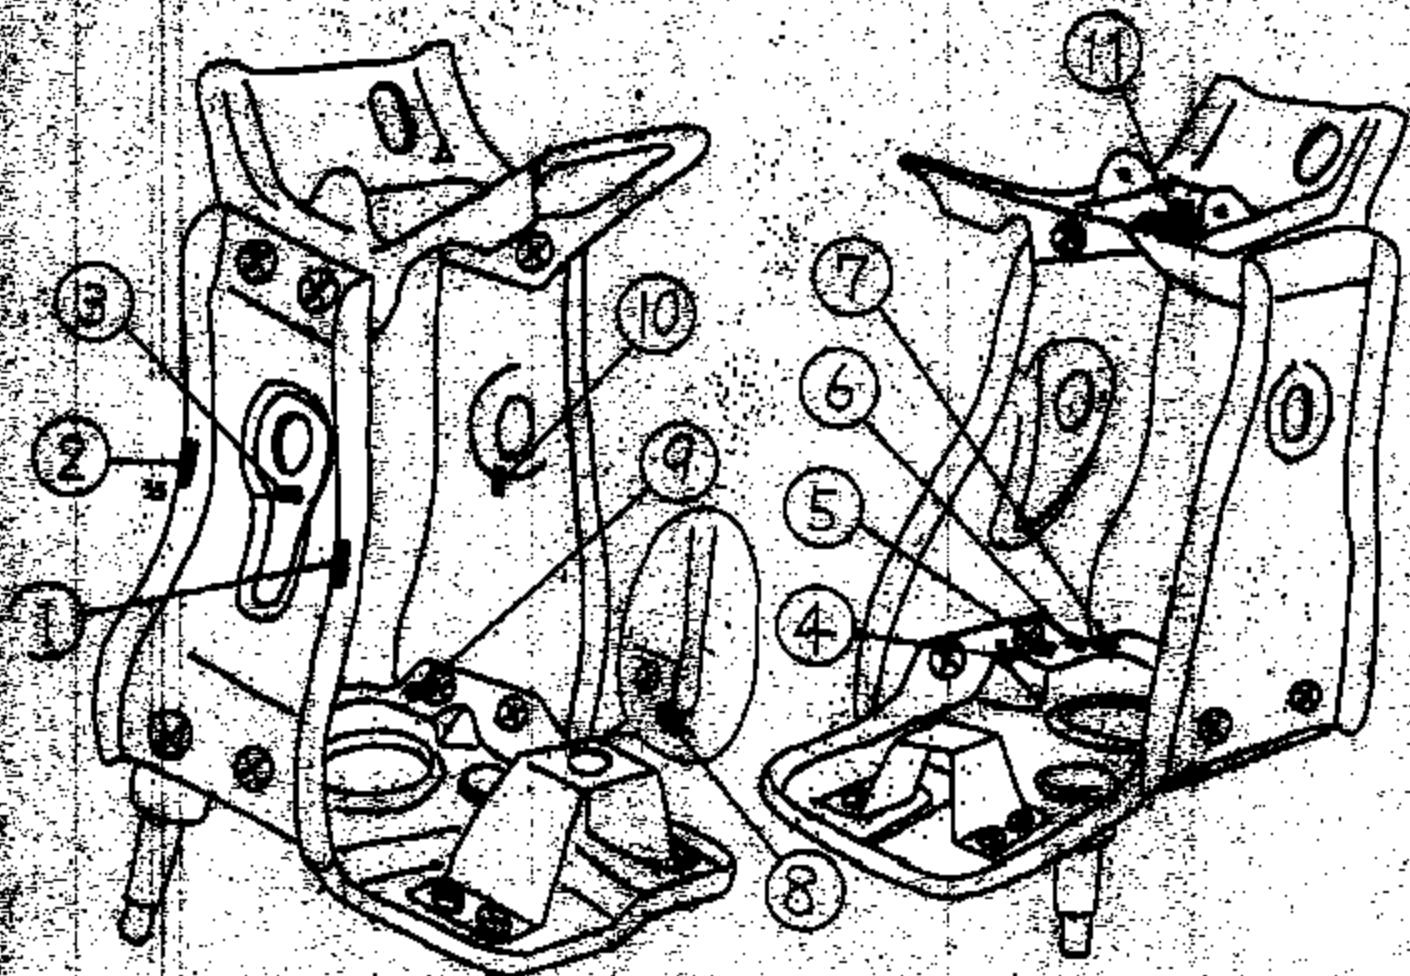
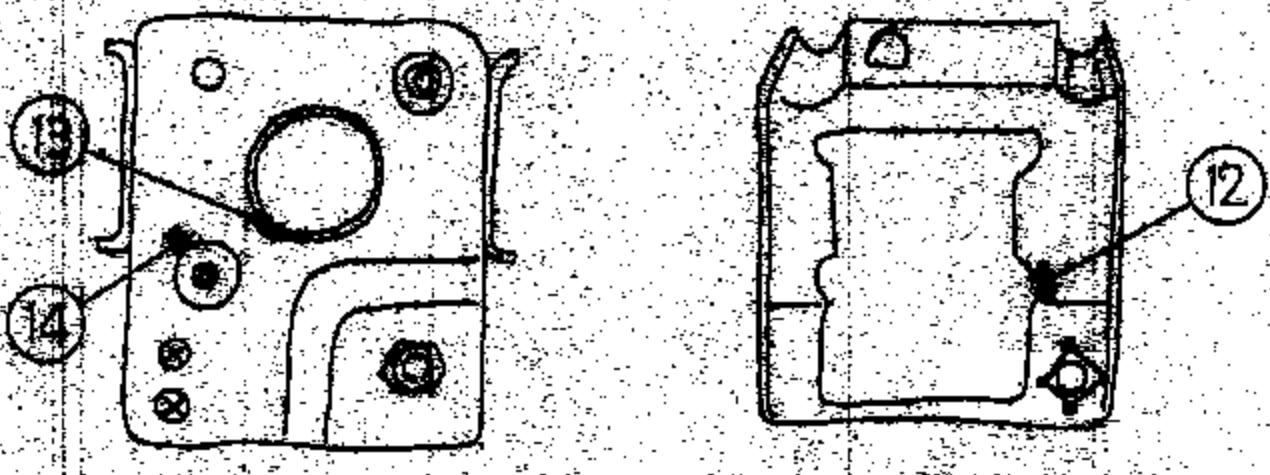
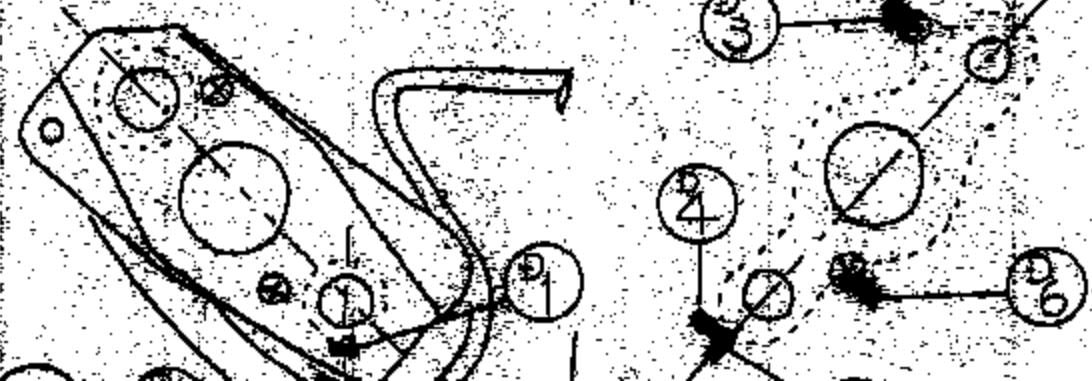
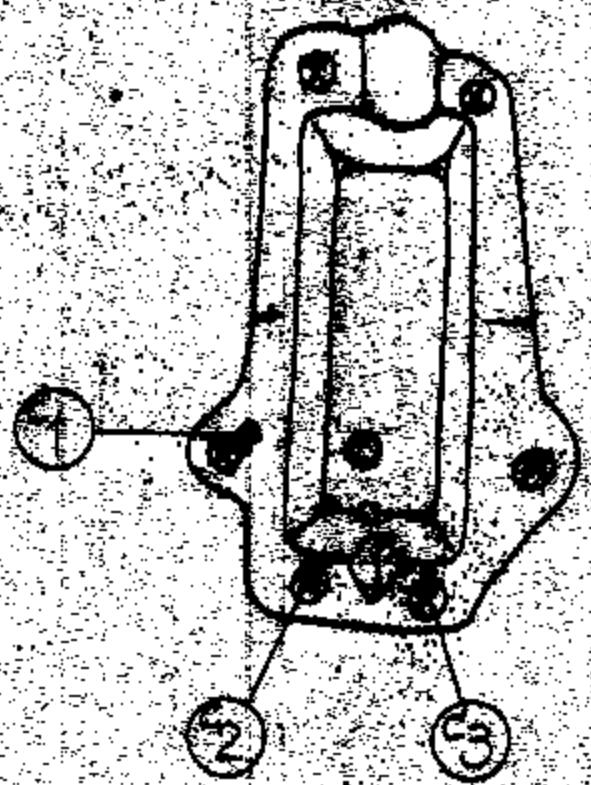
70077-4 BKT (対応品) 応力測定

- > T100 Electro pedal bracket stress distribution measurement setup
- > Countermeasures part (bracket, wheel / force on pedal) > 10kg -> 10kg
- > Unit: μ
- > Distortion (μ)
- > Gauge No.

- > T100 Clash bracket (countermeasures part) stress measurement

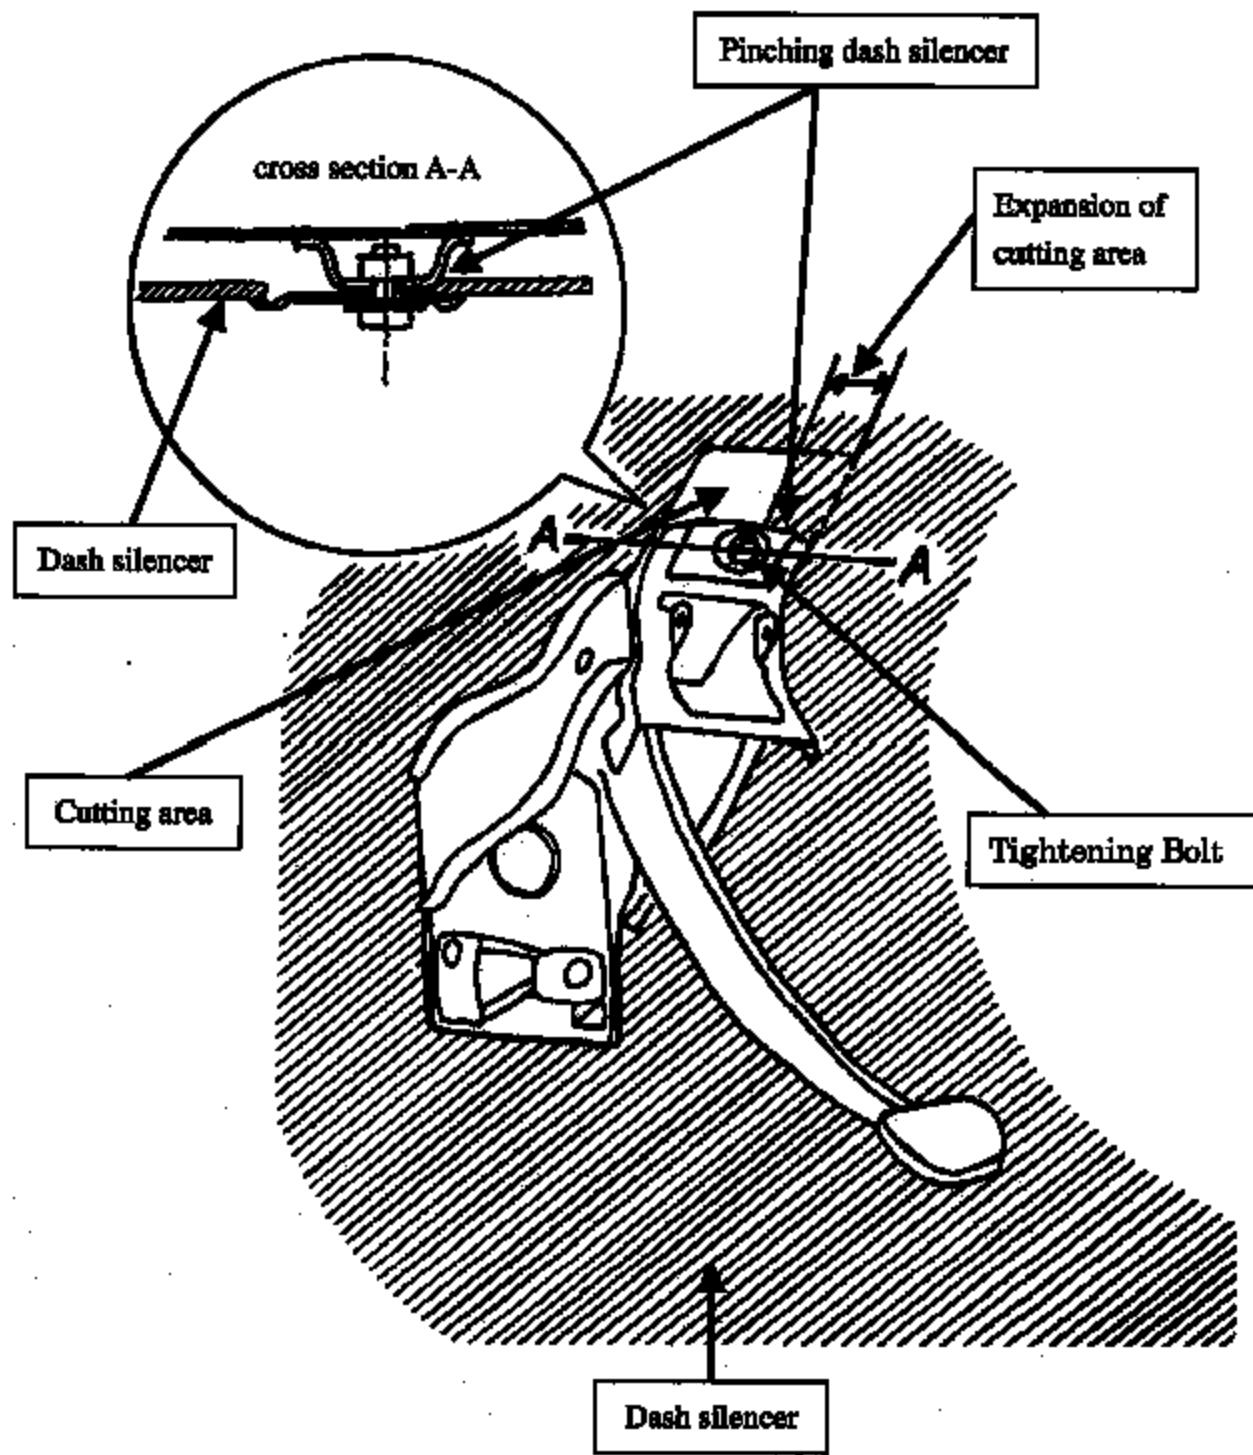
Crack in clutch pedal bracket
